Reliant Scimitar GTE

Run by Martin Port
 Owned since September '11
 Total mileage 67,120
 Miles since May report 1356
 Latest costs £1195

BELTING UP FOR A FAMILY WEDDING

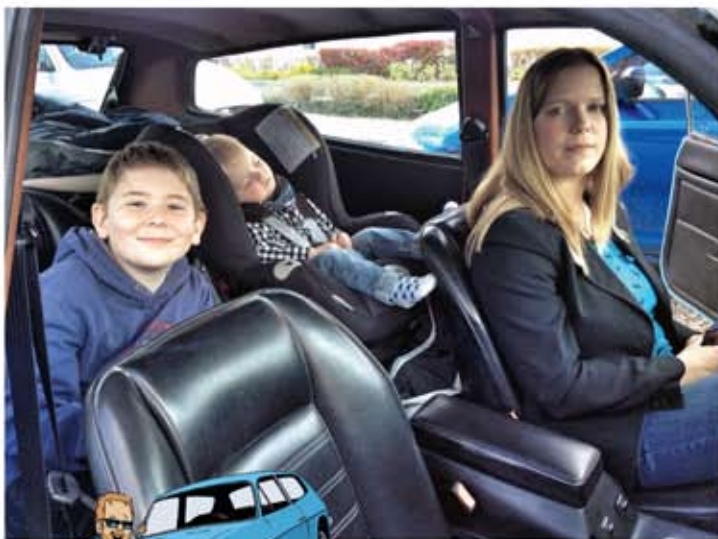
Ingenious bracket fixes to body mounts...

...and secures inertia reel beneath floor

The chaps chose the points at which the body bolts to the chassis for securing the necessary bracketry. They devised two heavy-duty fittings that spanned the boot floor on both sides while also running up under the side windows to provide the highest mounting point.

Only when I returned to collect the car did I get a chance to fully appreciate the ingenuity of their design, which included concealing the inertia reels themselves beneath the floor within the two cubbyholes originally provided for storage. The belts then run up the outside of the rear trim to a neat little post before heading forwards into the seat area, where the original lapbelt mountings are used.

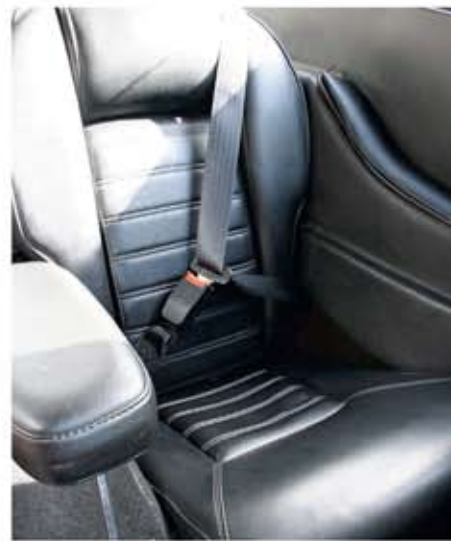
Et voilà! Three-point seatbelts in the rear

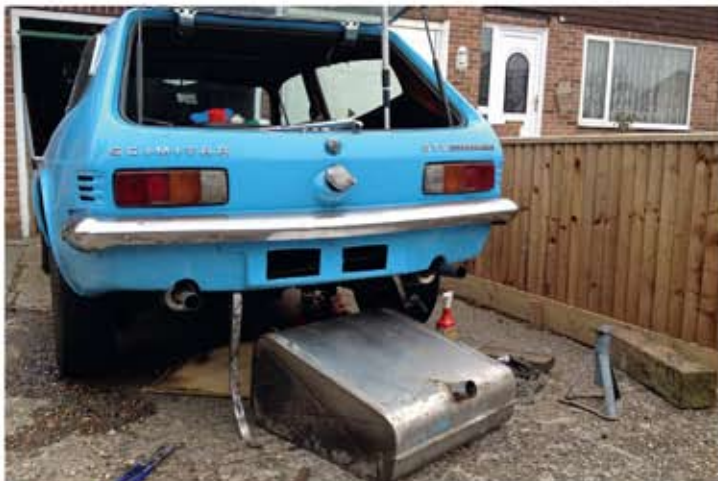
one of the fuel tank straps had snapped, allowing the tank to drop onto the rear valance, cracking the glassfibre in the process.

Broken strap hanging down and tank finally on the floor. And yes, that is fuel everywhere

I had no option other than to remove the tank and replace the aluminium straps, but soon realised that extracting a half-full tank was not a one-man job. Assistance came in the form of my local fourth emergency service (Phil and Oli from Classic Jaguar Replicas), who, on sensing the panic in my voice, immediately came to lend a hand.

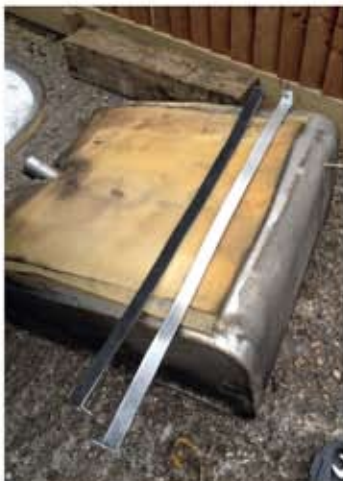
Thicker straps aren't right but do the job

With me still thinking that the aluminium straps were pukka, Oli knocked up a pair in something a bit thicker. The whole lot went back together more easily, with much less spilt fuel – and just one pair of hands – but, during a conversation with marque specialist Graham Walker, I subsequently found out that the straps should be steel. With a further set of replacements in the post, I avoided brimming the hefty tank until I had a chance to replace Oli's lovely bespoke straps with a pair of stainless items.

At the first opportunity, I roped in Elliott and we swapped the first strap, only to end up with a good inch or so of slack. Another call to GW revealed that there should be an inch-thick layer of insulation on top of the tank, but I knew that the only thing there was a manky bit of 4mm foam. So Oli's straps went back on, I swore about wasting the best part of two hours and thought about doing it all again – probably when the axle finally comes out for the impending diff rebuild, which is slowly getting a bit closer.
